FlightGear™ Radio Altimeter Cable Assembly

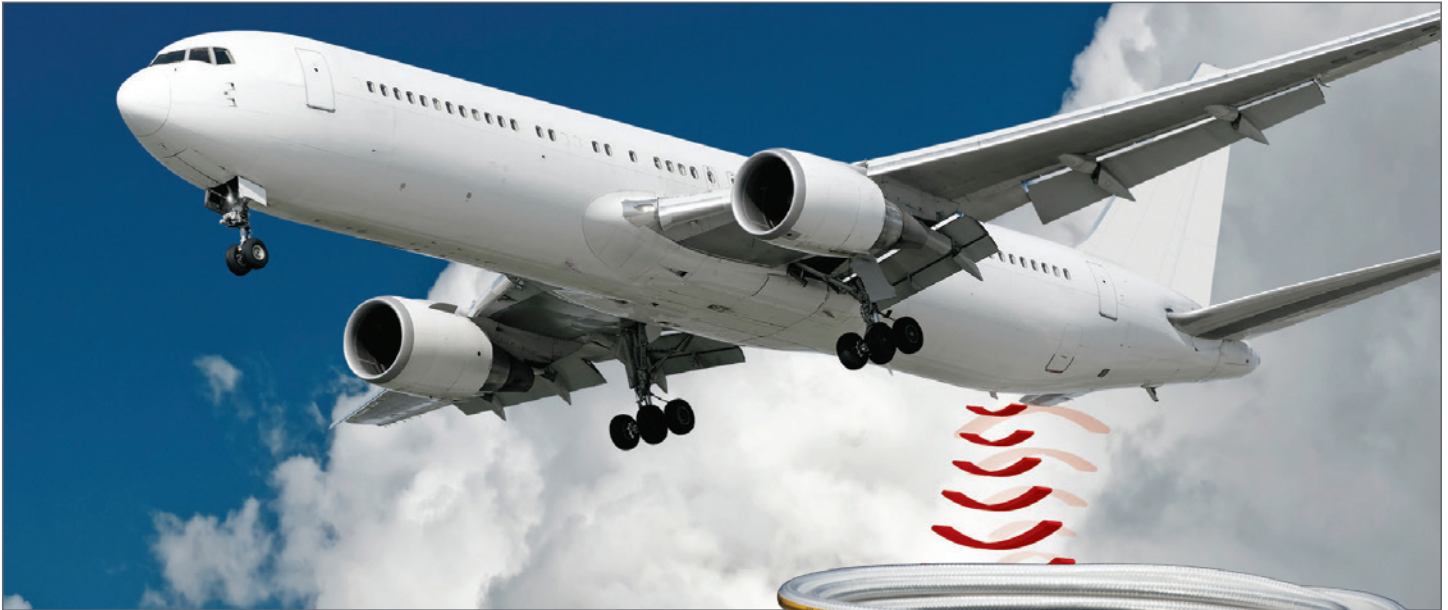
To address this issue, Amphenol CIT has developed the FlightGear™ Rad Alt Cable Assemblies that are designed and proven to withstand the constant pressurization cycles and the harsh SWAMP (Severe Weather and Moisture Prone) environment of the aircraft belly. The FlightGear™ Rad Alt Cable Assemblies help to greatly reduce or eliminate the costly problems and aircraft maintenance associated with radio altimeters and water ingress frequently occurring in other standard coax cable assemblies.

- » Robust design and construction
- » Special seals prevent water ingress into the cable and connector
- » Compatible with OEM and Airframe requirements
- » Available for multiple airframes
- » Easy installation and maintenance
- » Airworthiness Approved
- » In-house engineering and certification services

- » 6,000+ submerged pressurization life-cycles
- » Flammability per 14CFR Part 25.869
- » Vibration, Shock, Thermal Shock, Corrosion and Moisture Resistance per Mil-Std-202
